Modelling and Detecting Damage (Wear and RCF) in Rails

Prepared for The Railway Safety and Standards Board

Report: RRUk/A2/3

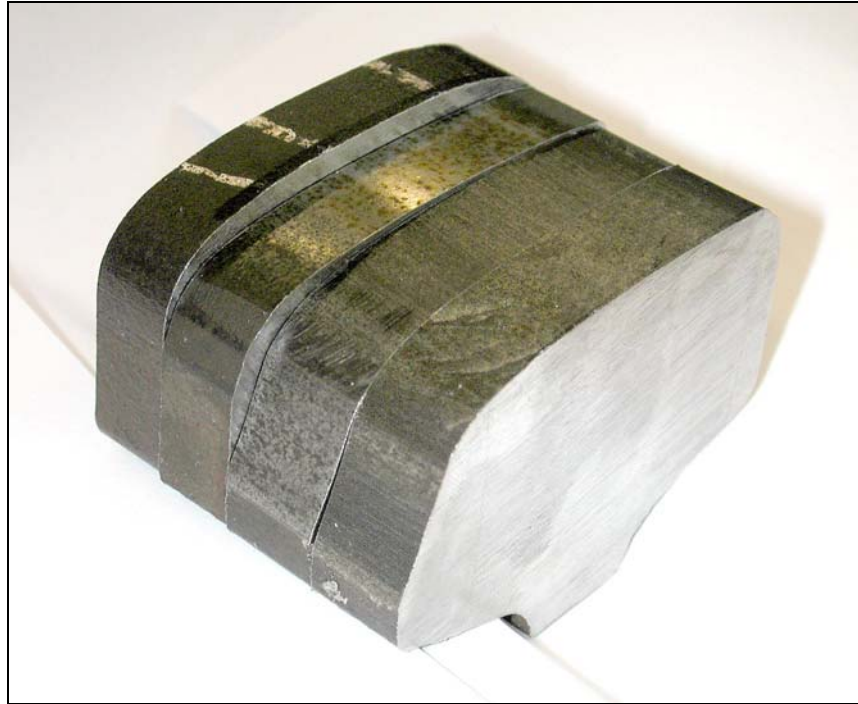
Figure 1. Transverse slices from rail samples A-B-C-D showing degree of wear.

Four rail samples were assessed; an unused rail and three rails taken out of service with different degradation levels (heavy wear, RCF cracks removed by grinding and severe RCF cracking). Sections from the four samples are presented in figure 1 showing different degrees of wear.

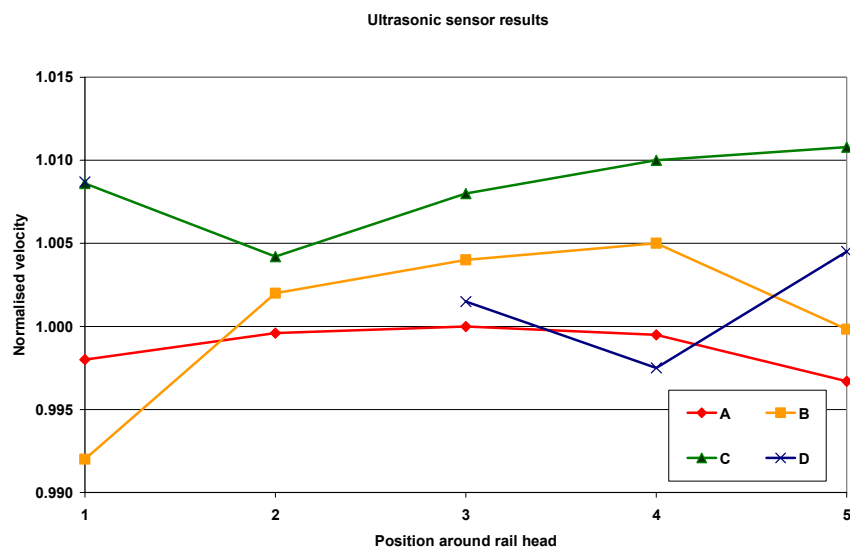
Figure 7. Ultrasonic sensor results for four rail samples.

velocities on each sample and relative variations between different samples. The results, shown in figure 7, indicate that there is little difference for rail A, as expected based on the rail being in the new condition where the microstructure would be relatively homogeneous. However, for the other rails significant differences can be seen in the normalised velocity, which will be caused by the differences in microstructure (due to the rails having different chemistries and differences in levels of deformation). It can also be seen that no reading was obtained for rail D in position 2, this is due to the presence of significant cracks being present at this position. This is a good approach to use in crack detection as conventional back-reflected inspection will not necessarily detect this type of crack. The HSE report of the Hatfield accident stated that the defects that caused track failure were probably 'missed' using conventional techniques.

Note that these are preliminary results and further tests showed slight variations in absolute differences between different samples, but good reproducibility on each sample.
